Llangollen Museum
Parade Street
Llangollen
LL20 8PW

ASBESTOS SURVEY REPORT

Survey: 0070-000:03-2016
Survey Date: 25/01/2021
Status: CURRENT

Site: 0070-000 - Llangollen Museum
Type: Reinspection

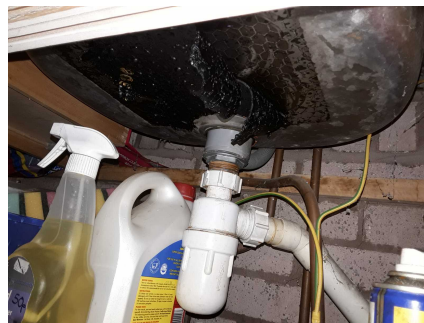
Site:	0070-000 - Llangollen Museum	Status:	DETECTED
Building:	0070-000-001 - Llangollen Former Library	Identified On:	
Room:	0/004 - Kitchen Area	Identified By:	D G Jones (JB Monitor) - J.B-Monitor Ltd
Description:	Asbestos bitumen pads		
Position:	Sink unit

Material Type:	Asbestos bitumen	Sample:	TAKEN
Material Subtype:		Asbestos Type:	1 - Chrysotile
Quantity:	2 Ea

Product Type:	1 - Asbestos reinforced composites (plastics, resins, mastics, roofing felts, vinyl floor tiles, semi-rigid paints or decorative finishes, asbestos cement etc)
Extent Damage:	1 - Low damage: a few scratches or surface marks; broken edges on boards, tiles etc
Surface Treatment:	0 - Composite materials containing asbestos: reinforced plastics, resins, vinyl tiles.
Asbestos Type:	1 - Chrysotile
Material Score:	3

Material Assessment Score:	3
Priority Assessment Score:	4
Total risk assessment score:	7
Overall Risk:	Very Low

Continue to manage all asbestos materials in place, plan to remove the sink pads in 2021/22 as a non urgent item.
