Drainage Report

Site
Llangollen Museum
Parade Street
Llangollen

Llangollen Museum LL208PW - CCTV Survey Report : 22/05/24

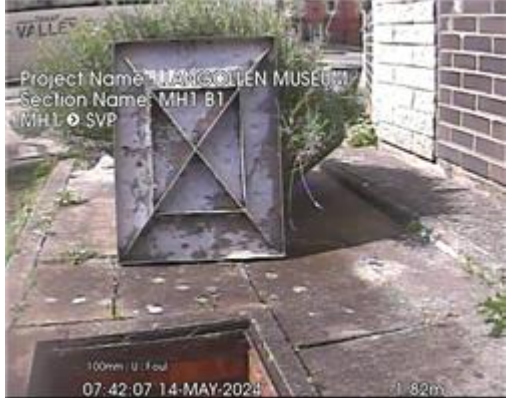
Pos	Video Ref	Code	Description	Image
00.00m		MH	Start node type, manhole MH1	<p>Image Provided - Ref: 0_0</p>

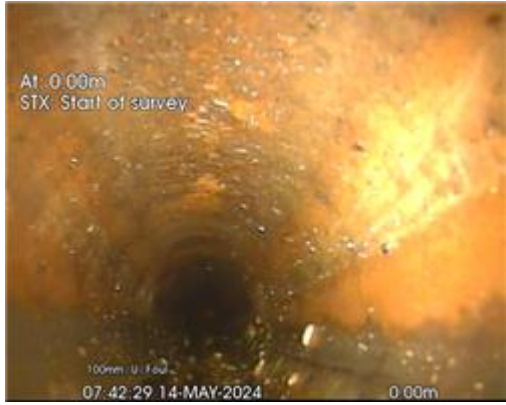
00.00m	0:00:00	WL	Water level: 0% Height/Diameter	<p>Image Provided - Ref: 0_1</p>

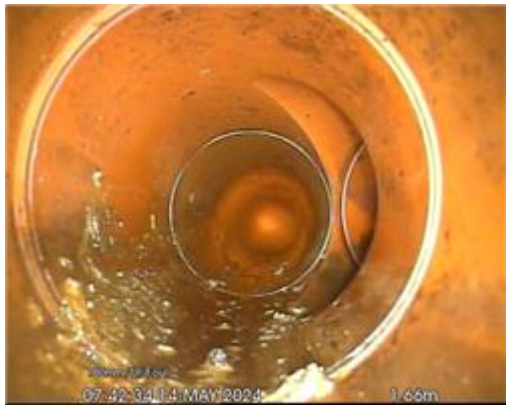
01.66m	0:00:21	JN	Junction at 03 o'clock: 100mm Diameter WC	<p>Image Provided - Ref: 0_2</p>

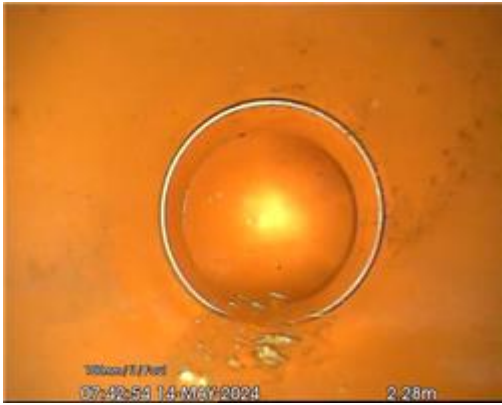
Pos	Video Ref	Code	Description	Image
02.28m	0:00:27	LRF	Line of drain/sewer deviates right [full]	<p>Image Provided - Ref: 0_3</p>

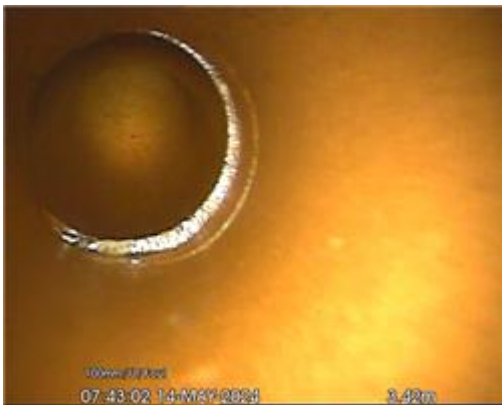
03.42m	0:00:35	MCVC	Material of pipe changes to Vitrified Clay (i.e. all clayware)	<p>Image Provided - Ref: 0_4</p>

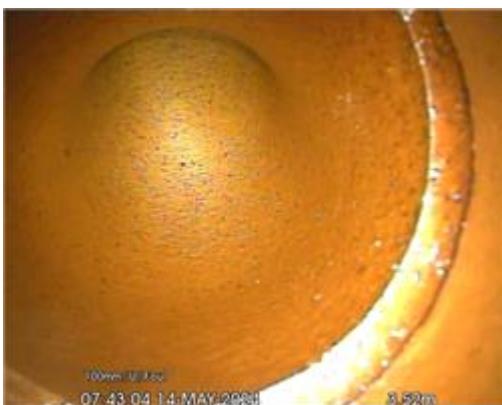
03.52m		MHF	Finish node type, manhole SVP Rest bend	<p>Image Provided - Ref: 0_9999</p>

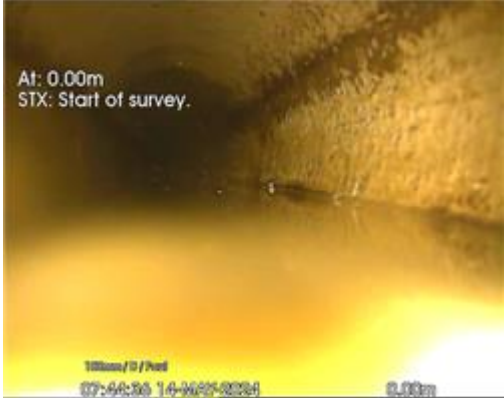
Pos	Video Ref	Code	Description	Image
00.00m		MH	Start node type, manhole MH1	<p>Image Provided - Ref: 1_0</p>

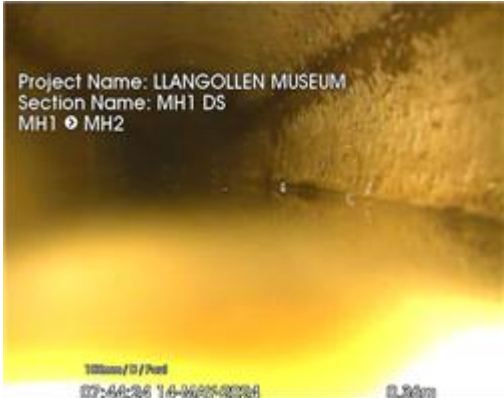
00.00m	0:00:00	WL	Water level: 20% Height/Diameter	<p>Image Provided - Ref: 1_1</p>

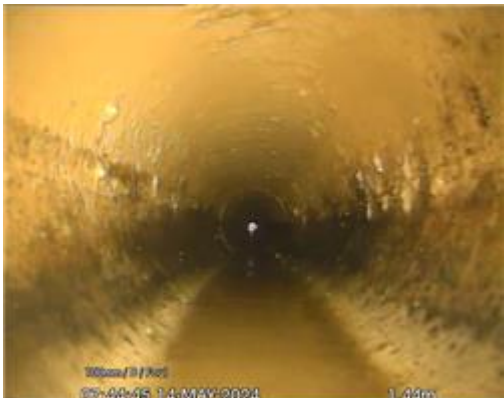
01.44m	0:00:15	WL	Water level: 5% Height/Diameter	<p>Image Provided - Ref: 1_2</p>

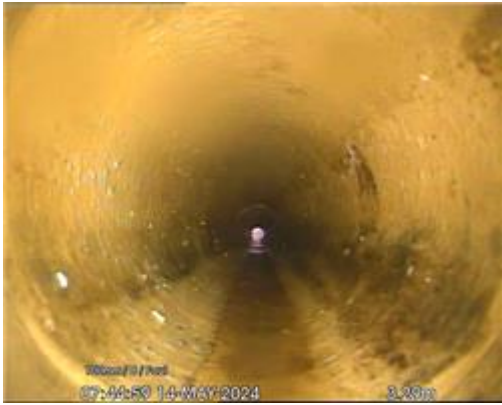
Pos	Video Ref	Code	Description	Image
03.29m	0:00:24	REM	General remark	<p>Image Provided - Ref: 1_3</p>

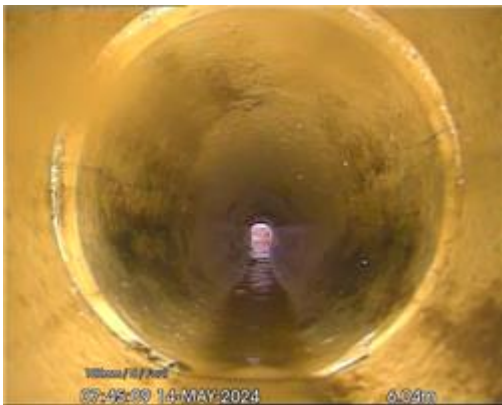
06.04m	0:00:33	REM	General remark	<p>Image Provided - Ref: 1_4</p>

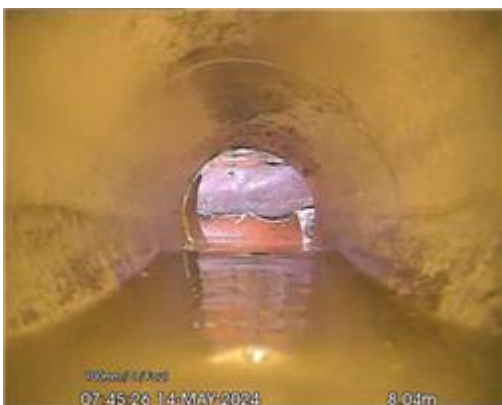
08.04m	0:00:45	CC	Crack, circumferential from 10 o'clock to 02 o'clock - Severity 1	<p>Image Provided - Ref: 1_5</p>

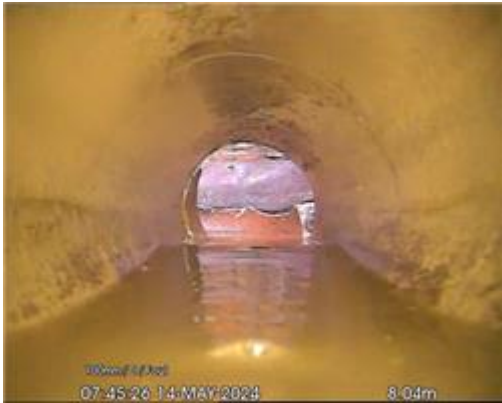
Pos	Video Ref	Code	Description	Image
08.04m	0:00:45	WL	Water level: 15% Height/Diameter	<p>Image Provided - Ref: 1_6</p>

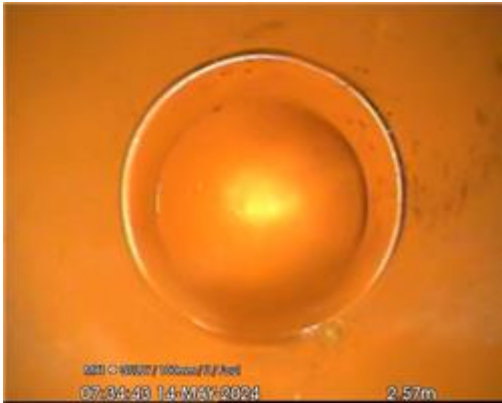
Pos	Video Ref	Code	Description	Image
02.57m	0:01:17	LRF	Line of drain/sewer deviates right [full]	<p>Image Provided - Ref: 2_3</p>

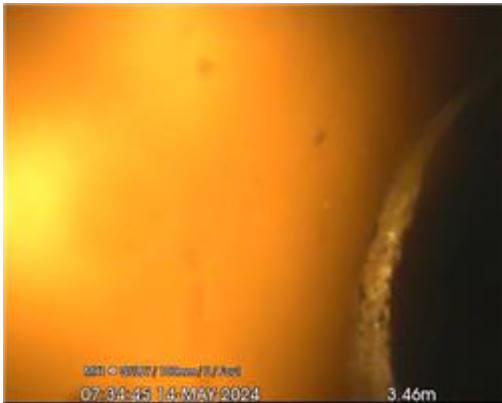
03.46m	0:01:19	MCVC	Material of pipe changes to Vitrified Clay (i.e. all clayware)	<p>Image Provided - Ref: 2_4</p>

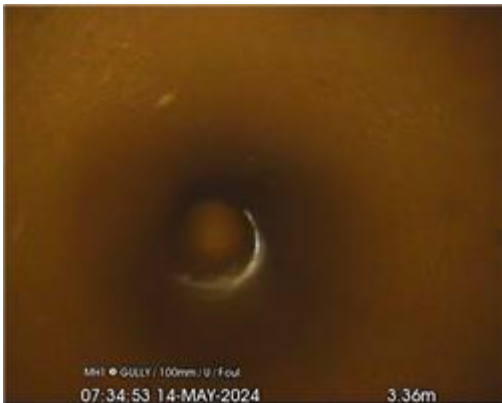
03.50m		MHF	Finish node type, manhole Gully	<p>Image Provided - Ref: 2_9999</p>

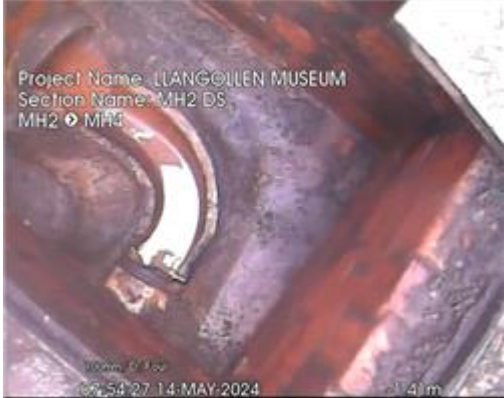
Pos	Video Ref	Code	Description	Image
00.00m		MH	Start node type, manhole MH2	<p>Image Provided - Ref: 3_0</p>

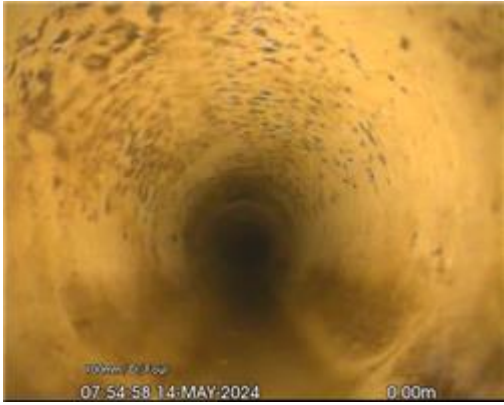
00.00m	0:00:00	WL	Water level: 0% Height/Diameter	<p>Image Provided - Ref: 3_1</p>

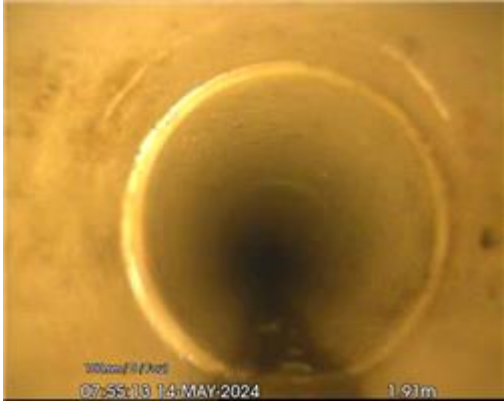
01.91m	0:00:31	REM	General remark	<p>Image Provided - Ref: 3_2</p>

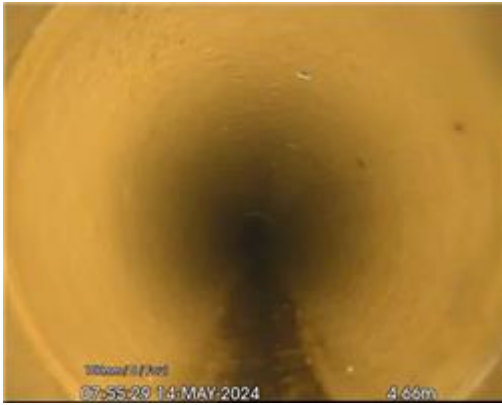
Pos	Video Ref	Code	Description	Image
04.66m	0:00:39	REM	General remark	<p>Image Provided - Ref: 3_3</p>

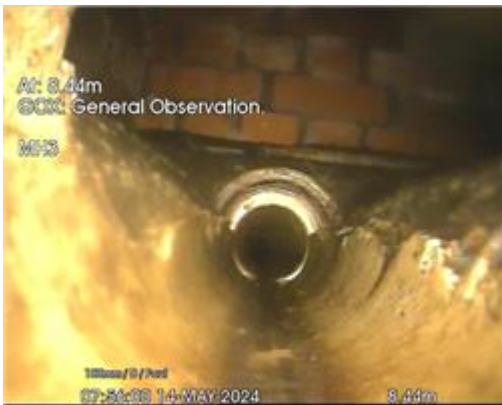
08.46m	0:00:58	REM	General remark MH3	<p>Image Provided - Ref: 3_4</p>

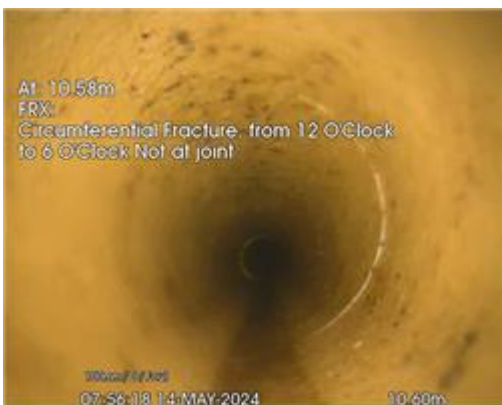
10.30m	0:01:04	CC	Crack, circumferential from 12 o'clock to 06 o'clock - Severity 1	<p>Image Provided - Ref: 3_5</p>

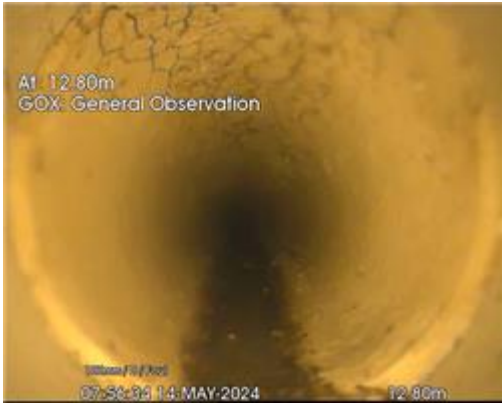
Pos	Video Ref	Code	Description	Image
12.80m	0:01:18	REM	General remark	<p>Image Provided - Ref: 3_6</p>

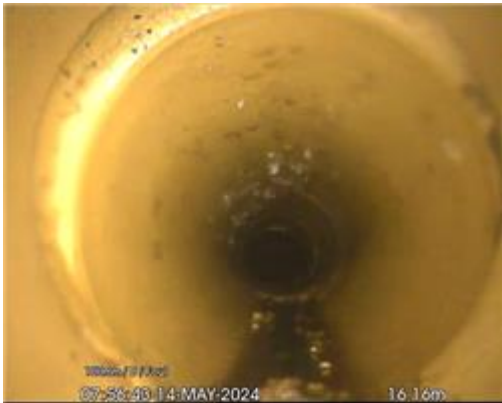
<p>At 12.80m GOX- General Observation</p> <p>07:56:39 14 MAY 2024 12.80m</p>
16.16m	0:01:30	JDM	Joint displaced medium - Severity 3	<p>Image Provided - Ref: 3_7</p>

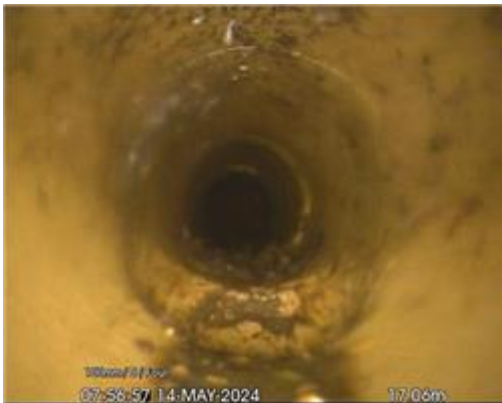
<p>07:56:48 14 MAY 2024 16.16m</p>
17.06m		MHF	Finish node type, manhole MH4 Drop Shaft	<p>Image Provided - Ref: 3_9999</p>

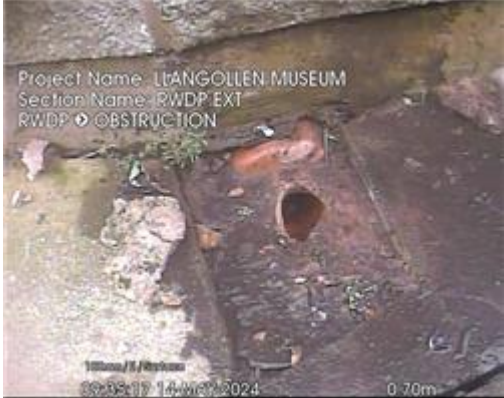
Pos	Video Ref	Code	Description	Image
00.00m		MH	Start node type, manhole RWDP	<p>Image Provided - Ref: 4_0</p>

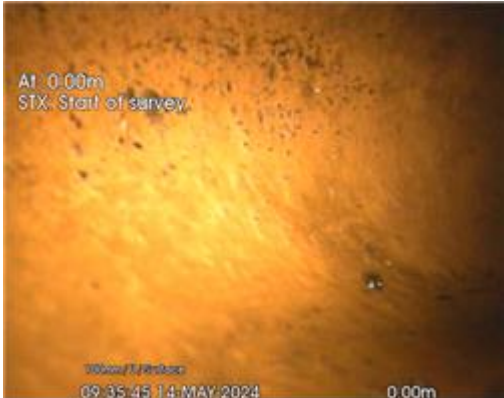
00.00m	0:00:00	WL	Water level: 0% Height/Diameter	<p>Image Provided - Ref: 4_1</p>

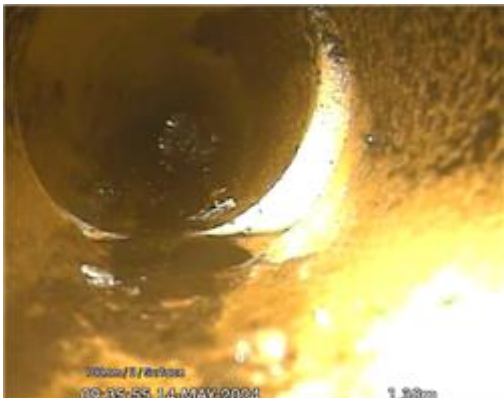
01.38m	0:00:28	JDL	Joint displaced large - Severity 4	<p>Image Provided - Ref: 4_2</p>

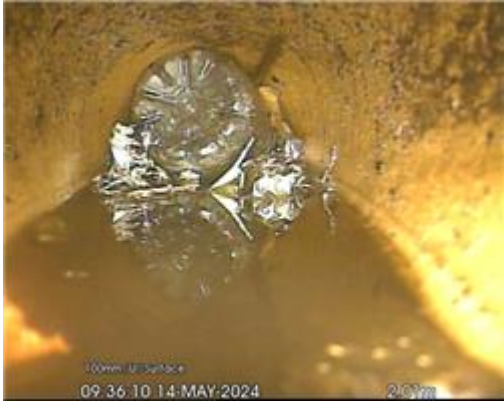
Pos	Video Ref	Code	Description	Image
02.01m	0:00:35	OB	Other obstacles: 95% Cross sectional area loss - Severity 3 Drinks bottle	Image Provided - Ref: 4_3

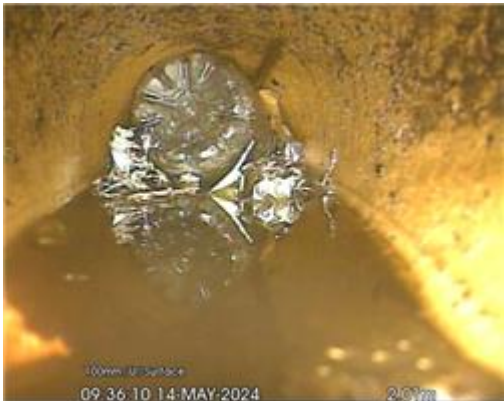
02.01m		SA	Survey abandoned Unable to pass bottle	Image Provided - Ref: 4_9999
