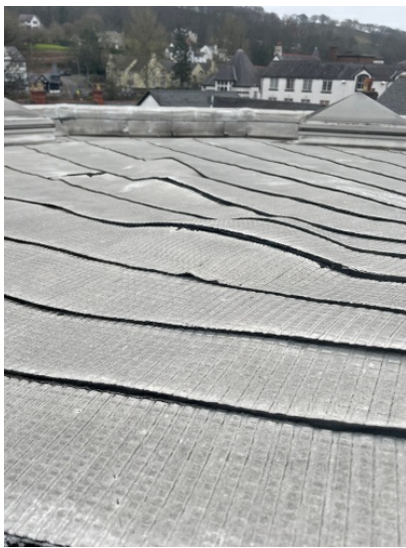
*Photo 1*

Extreme blistering and poor lap joint adhesion at existing roof level.

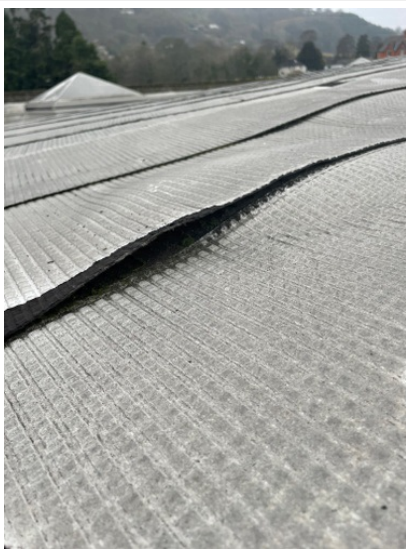
*Photo 2*

One of many lap joints delaminating, contributing to several weak points allowing water ingress.

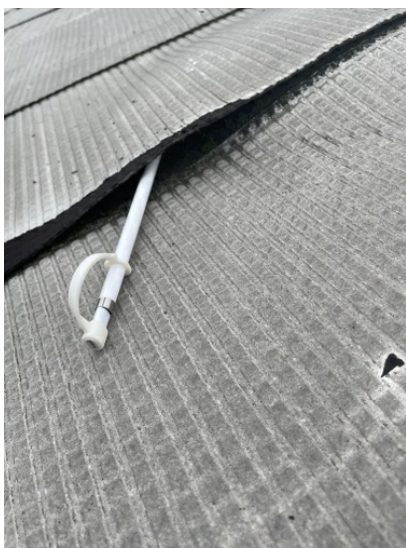
*Photo 3*

Here my pen highlights the scale of the defects.

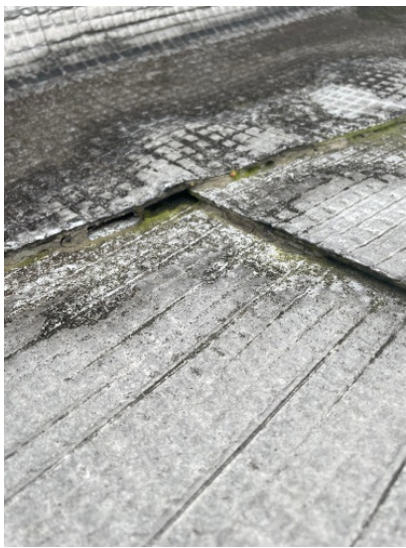
*Photo 4*

Delamination on lap joints toward the roofs perimeter.

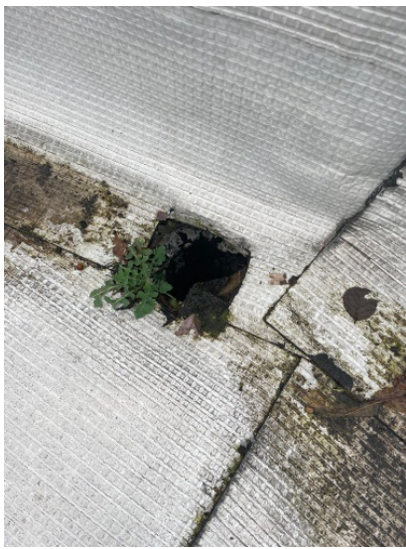
*Photo 5*

Outlet area, Water is holding underneath the waterproofing causing vegetation growth.

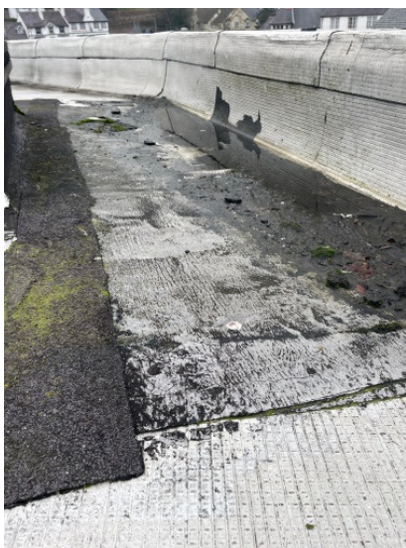
*Photo 6*

A large attempted patch work repair using low grade felt and standing water to the perimeter.

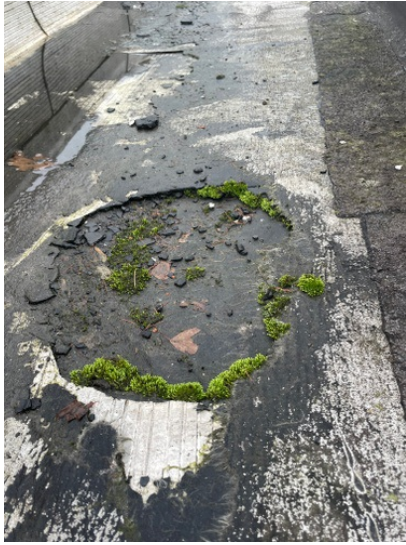
*Photo 7*

A large hole in the waterproofing with vegetation growth.

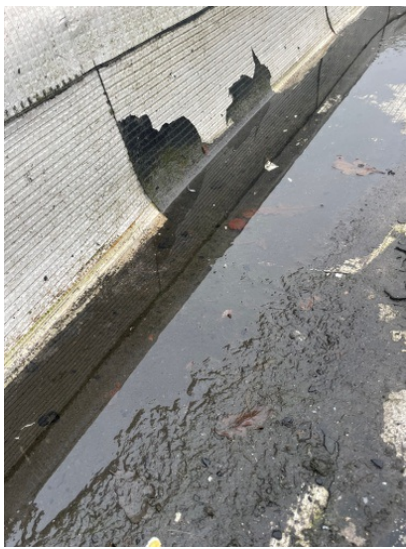
*Photo 8*

Standing water and silt deposits gathering.

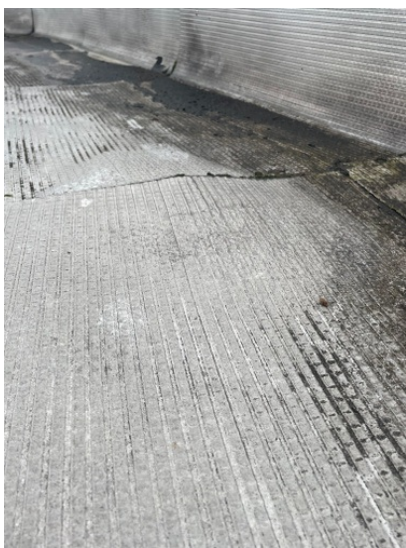
*Photo 9*

Blistering and standing water towards the parapet.

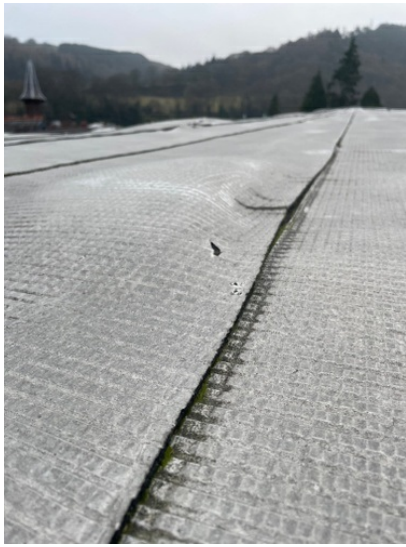
*Photo 10*

Delamination and lap slippage to field area of the roof.

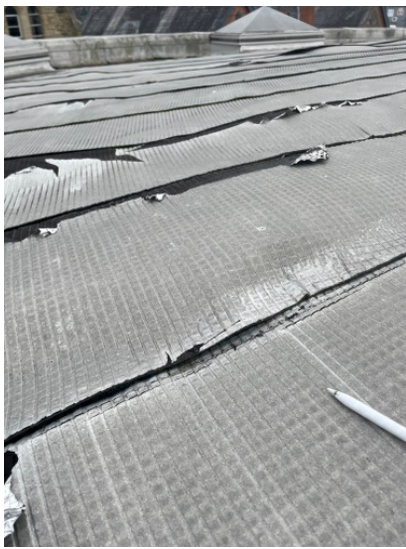
*Photo 11*

Blistering, lap slippage, and delamination.

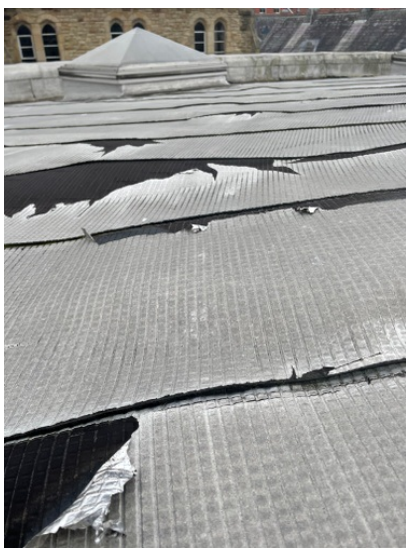
*Photo 12*

defective waterproofing, missing foil protection and extreme blistering.

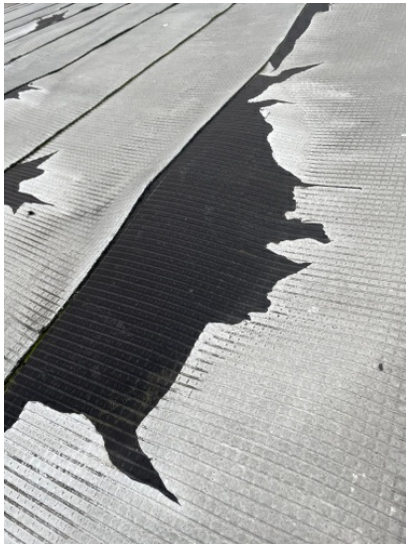
*Photo 13*

Missing foil UV protection.

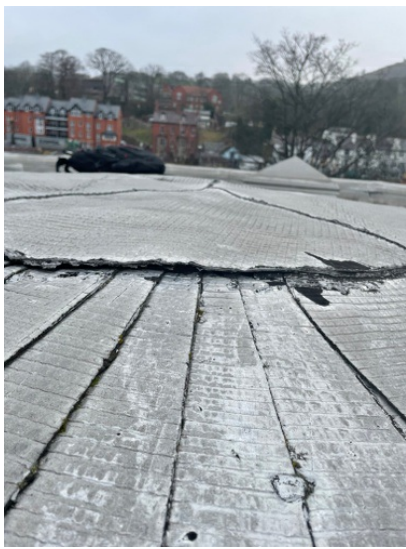
*Photo 14*

Crown of the roof begin to delaminate.

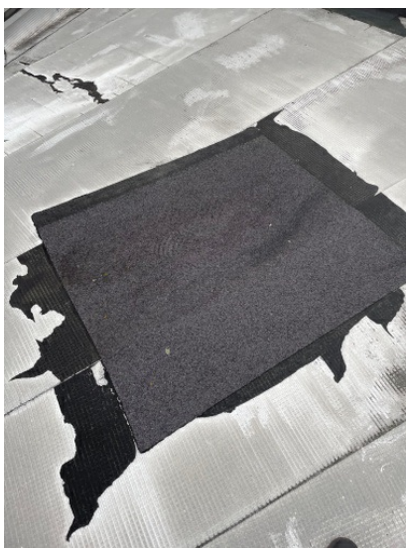
*Photo 15*

A further large attempted patch work repair using low grade felt.

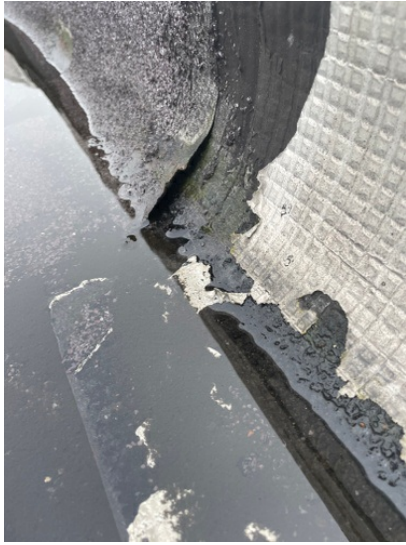
*Photo 16*

Open laps at the parapet.

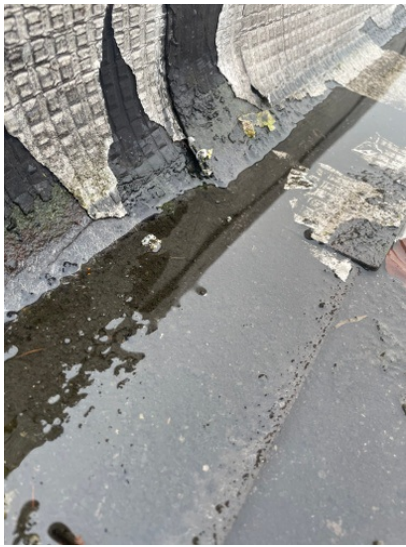
*Photo 17*

Further standing water and void at the lap.

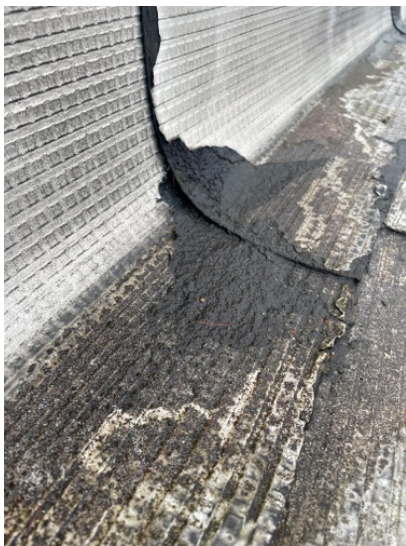
*Photo 18*

Delamination and lap slippage at the parapet.

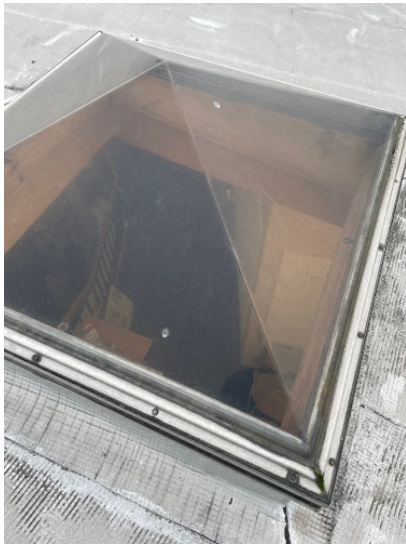
*Photo 19*

Single skin rooflight. Id say these are well in excess of 30 years old.

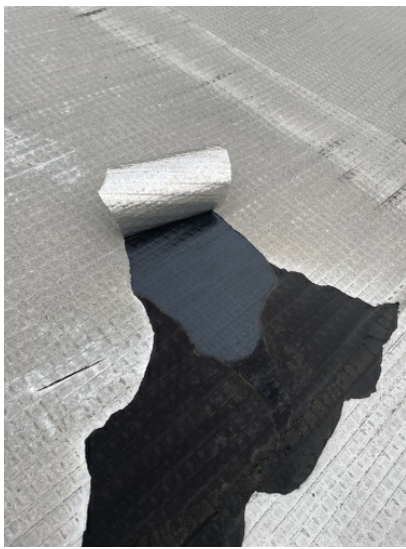
*Photo 20*

Foil face peeling.

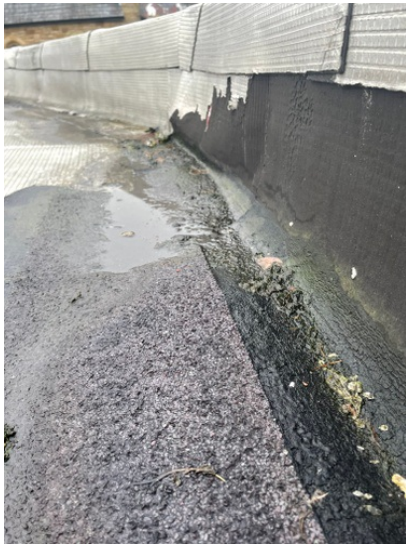
*Photo 22*

Patch work repair, missing foil face protection.

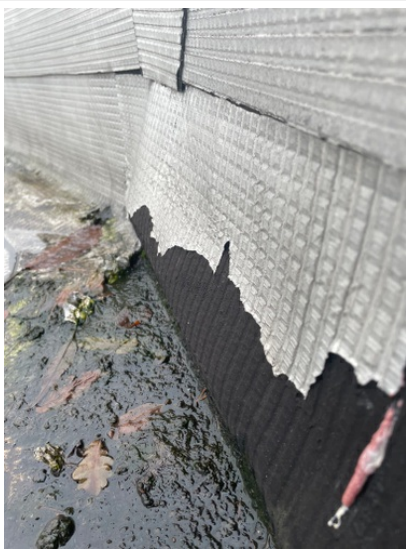
*Photo 23*

Standing water above defective area.

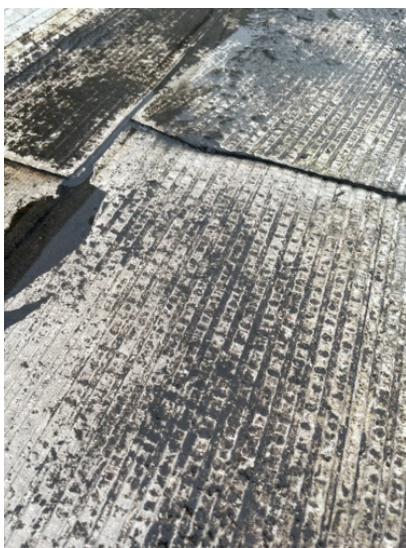
*Photo 24*

lap slippage

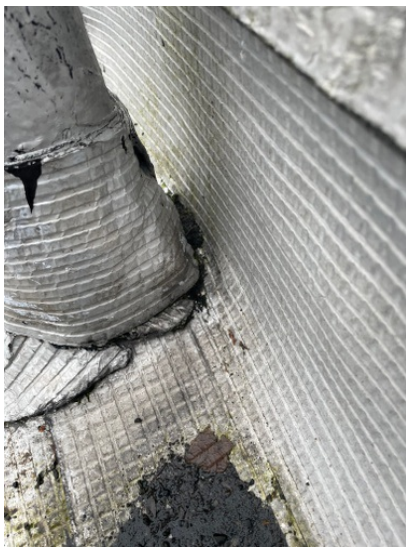
*Photo 26*

Poor detailing to soil pipe penetration.

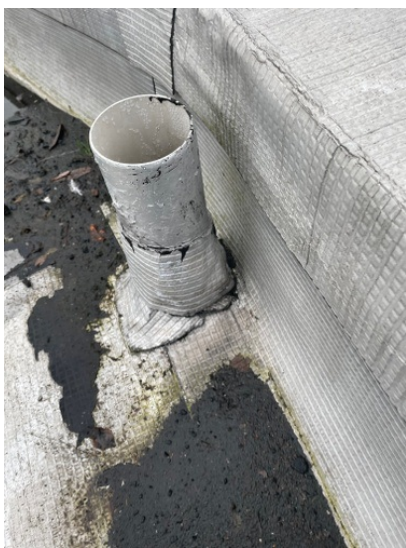
*Photo 27*

A further image of soil pipe detailing.

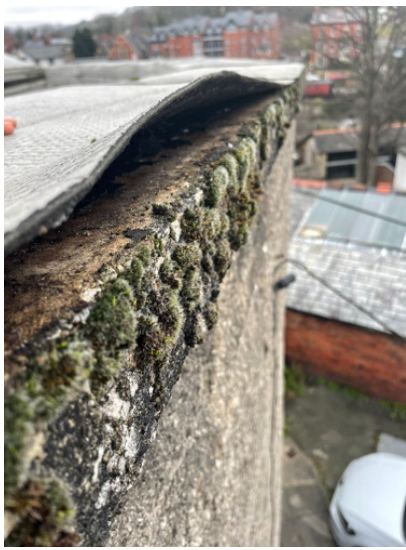
*Photo 28*

Delamination of waterproofing to top face of parapet. This is evident in several areas.

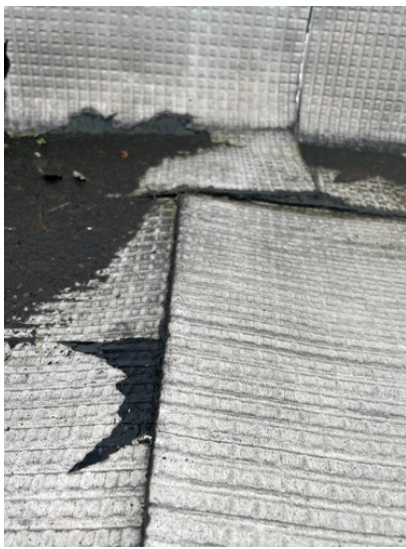
*Photo 29*

Junction between parapet upstand and field area lap joint with defects.

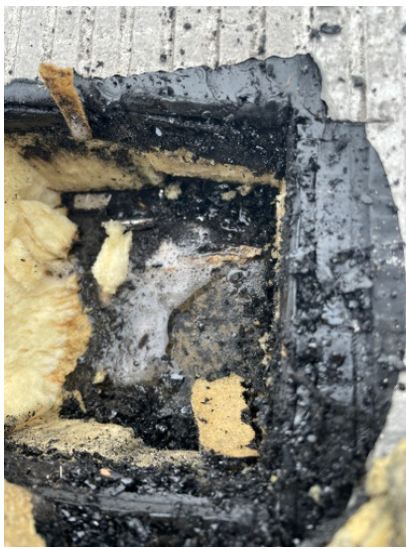
*Photo 35*

Core sample location 2. Water below insulation and insulation is saturated.

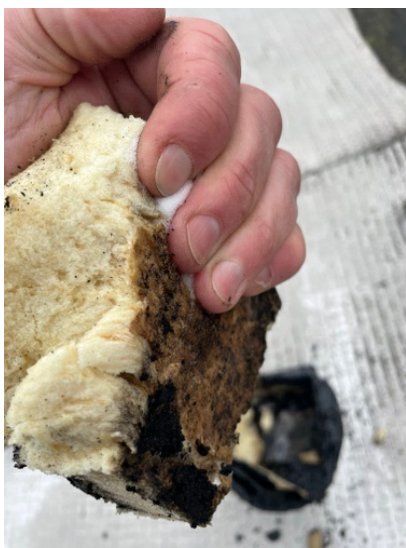
*Photo 36*

Saturated insulation.

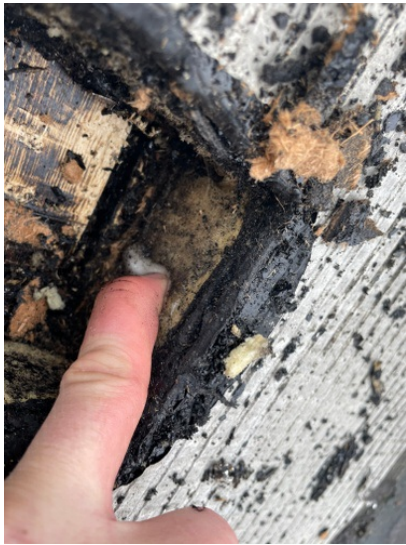
*Photo 40*

Core 3. Note where my finger is applying pressure, water exits.

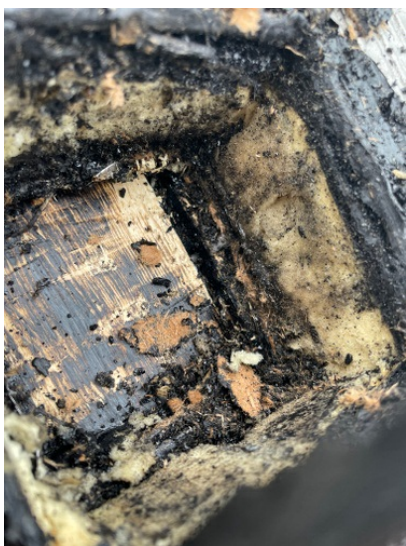
*Photo 45*

Timber blank below BUR seems in good order at core location.
