Customer LLANGOLLEN MUSEUM
Contact Dave Crane ()

Job type CCTV Survey - Pre booked

Reference CCTV5257

Date 15/05/2024 08:00

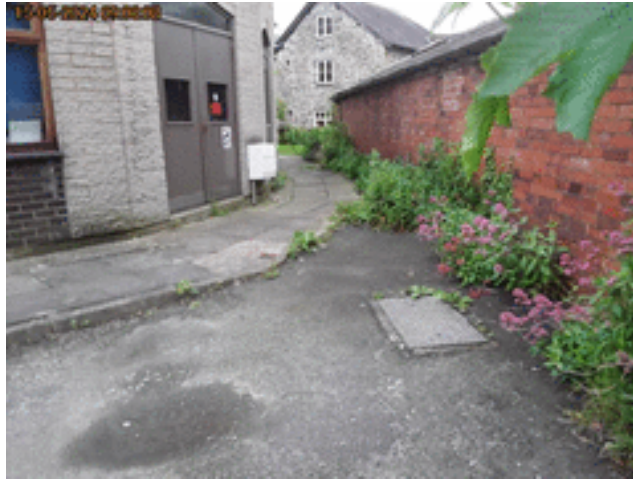
Take an overview photo of work area before starting work
