Client – Llangollen Museum

Reference – 20240045-PRA

Date – 24th May 2024

Preliminary Roost Assessment (PRA)

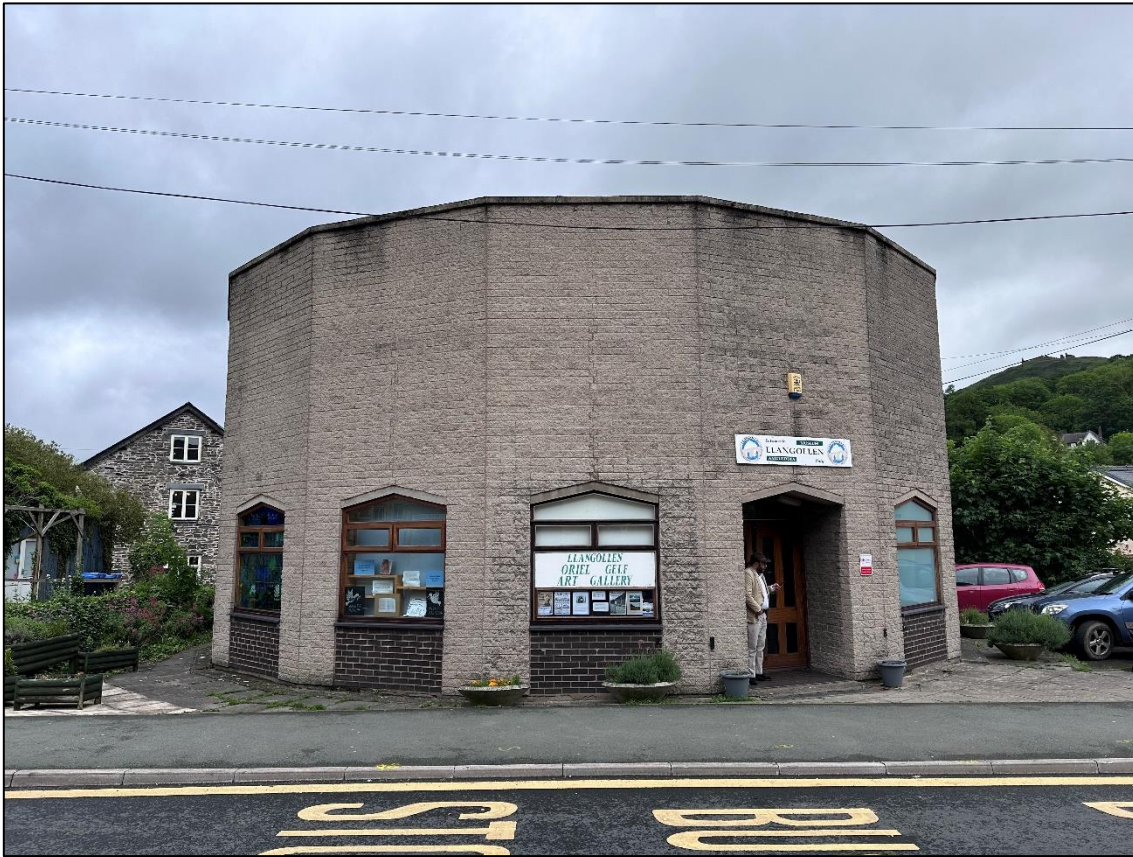
2.2.3. The roof of the building comprises a material covered roof that slopes from a central point. There are occasional roof lights present and an internal guttering system, that outfalls to several holes present around the edge of the roof. A material covered parapet extends around the perimeter of the roof.

2.2.4. Internally the building comprises predominantly one space open to the inside of the roof with no separated roof void.

Figure 2: The Llangollen Museum.

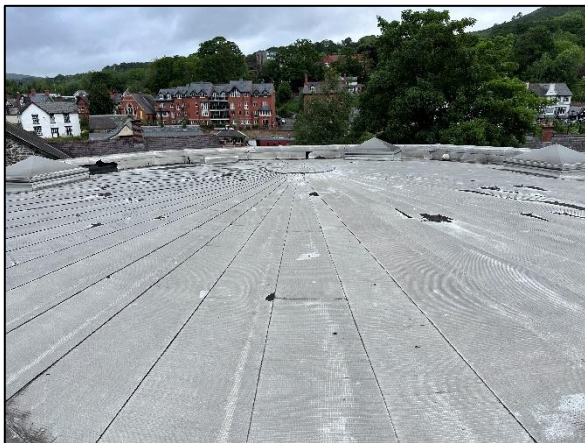
Figure 3: The roof of the building.

4.2.6. The roof of the building was found to be in a deteriorating condition with occasional voids present in the material roof covering. The voids were inspected and were generally considered unsuitable for roosting bats due to the nature of the voids and the presence of areas of standing water on the roof.

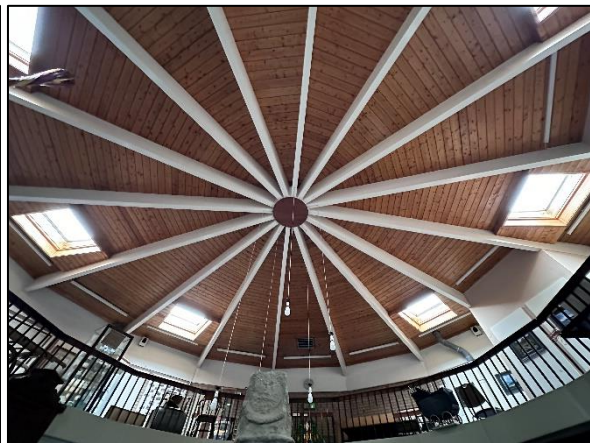
Figure 4: The interior of the building.

4.2.8. No access points were identified that would provide bats with access to the interior of the building.

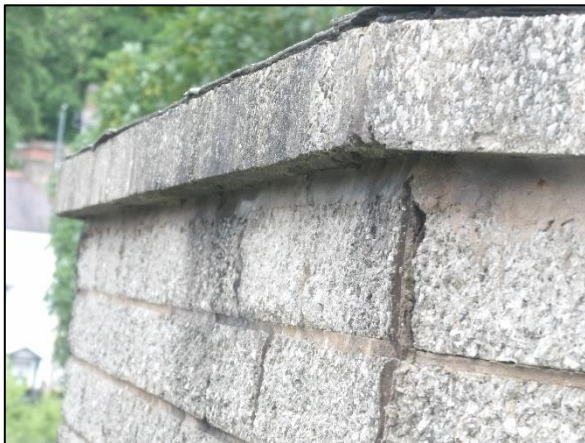
4.2.3. The coping stones around the top of the walls were found to be intact and well pointed to the walls, providing no opportunities for roosting bats.

Figure 6: The pointing around the coping stones.

4.2.7. Occasional small voids were identified under the edge of the roofing material, along the top of the coping stones. The voids were considered suitable for individual bats to seek opportunistic shelter, although did not lead to any significant cavities that would provide roosting opportunities.

5.2. It is recommended that the removal of the existing roof covering, specifically in relation to the area over the coping stones, is carried out with care. In the event that bats or bat field signs are identified during the works all work on site should cease immediately and further advice should be sought.

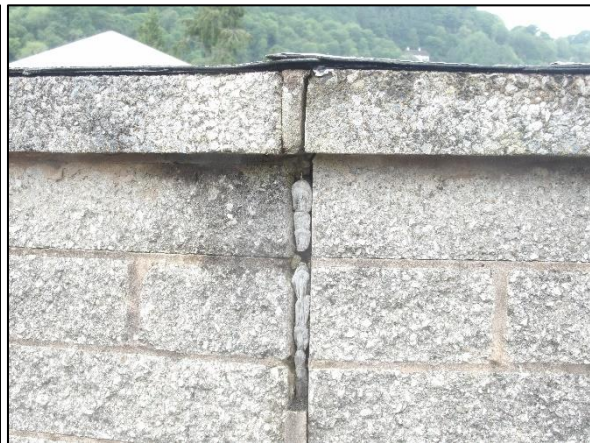
4.2.1. The walls of the building were found to be in a good condition with no major cracks or voids. Occasional minor pointing voids were identified high on the walls of the building, although a close inspection of the voids identified them to be shallow and unsuitable for roosting bats.

Figure 7: Minor voids in the stonework.

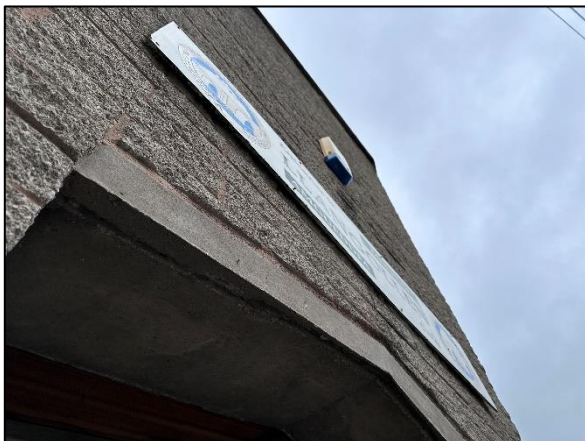
4.2.4. Occasional signs, lights and an alarm box were identified on the external stonework of the building. The external fixtures provide occasional opportunities for bats to seek shelter, in particular behind the Llangollen Museum sign, although no bat field signs were identified during this survey.

Figure 8: Voids behind the signage.

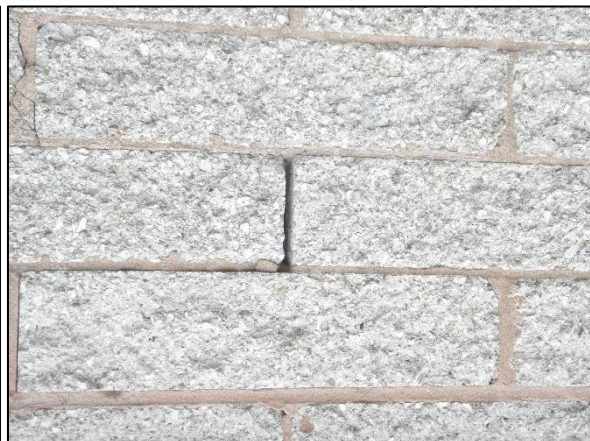
4.2.5. Small vents were also identified around the higher areas of the brickwork on the building, comprising vertical areas of missing pointing. The voids were considered too small to provide suitable opportunities for roosting bats.

Figure 9: Vents high in the brickwork.
