Drainage Report

Site
Llangollen Museum
Parade Street
Llangollen

Llangollen Museum LL208PW - CCTV Survey Report : 22/05/24

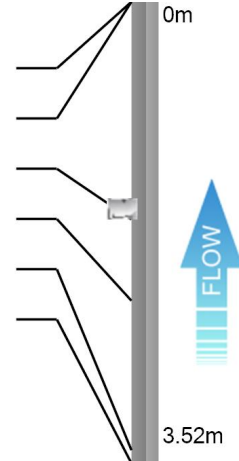
00.00m	WL	Water level 0%		0_1	0:00:00	
01.66m	JN	Junction 03 : 100mm Diameter		0_2	0:00:21	
02.28m	LRF	Line of drain/sewer deviates right [full]		0_3	0:00:27	
03.42m	MC	Material of drain/sewer changes		0_4	0:00:35	
03.52m	MHF	Finish node type, manhole		0_99

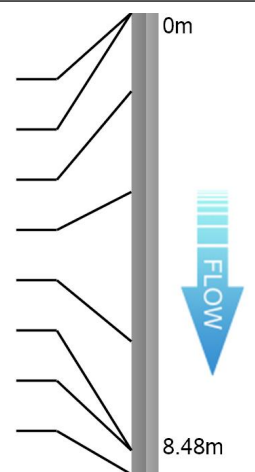
Position	Code	Description	CD	Pic	Video Ref	
00.00m	MH	Start node type, manhole		1_0		
00.00m	WL	Water level 20%		1_1	0:00:00	
01.44m	WL	Water level 5%		1_2	0:00:15	
03.29m	REM	General remark		1_3	0:00:24	
06.04m	REM	General remark		1_4	0:00:33	
08.04m	CC	Crack, circumferential 10-02		1_5	0:00:45	
08.04m	WL	Water level 15%		1_6	0:00:45	
08.48m	MHF	Finish node type, manhole		1_99

08.04m	0:00:45	CC	Crack, circumferential from 10 o'clock to 02 o'clock - Severity 1	<p>Image Provided - Ref: 1_5</p>
